VOLVO VN / VNL FOG / DRIVING LIGHT

Item # 32648 / 32649 / 32693 / 32694

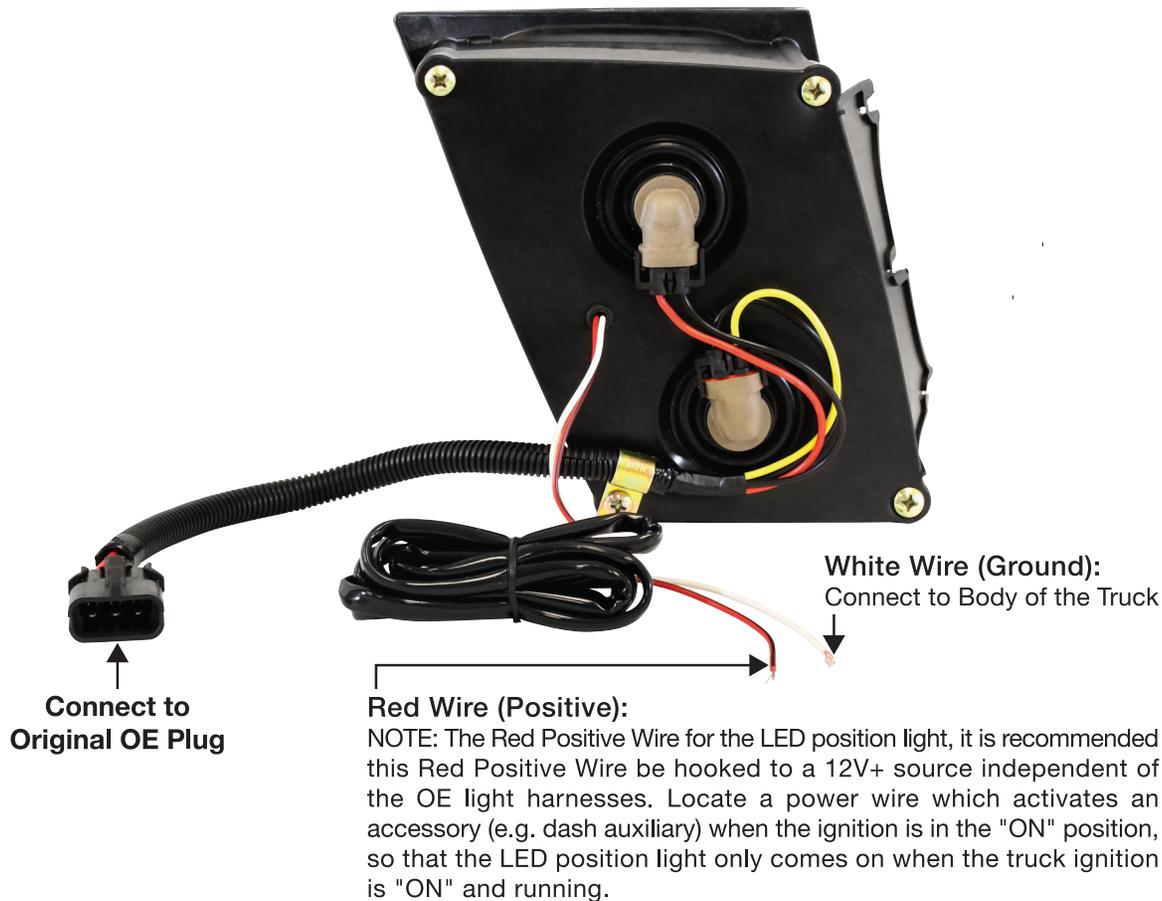
NORMAL FOGGING / CONDENSATION

On rare occasions, light fogging may occur. Light fogging is a normal occurrence and lamp assembly replacement **WILL NOT** be necessary.

A drop in air temperature may cause condensation to form on the inside of a cool lamp lens. Generally, fogging is considered normal and can be eliminated by turning on the lamp with the engine running for several minutes. In most cases, operating the vehicle in normal driving condition will clear the lamp fogging. Therefore, lamp assembly replacement **WILL NOT** be necessary in most cases.

- If any of the following conditions occur, please consult with a professional mechanic to determine the water source:
 - 1) If condensation/fogging fails to dissipate after operating the headlight with the engine running for 30 minutes
 - 2) If water pooled inside the lamp
- A high pressure washer may also cause water to be forced into the lamp assembly.
