HIGH POWER LED HEADLIGHT

Item Numbers: 35771, 35772, 35773, 35774

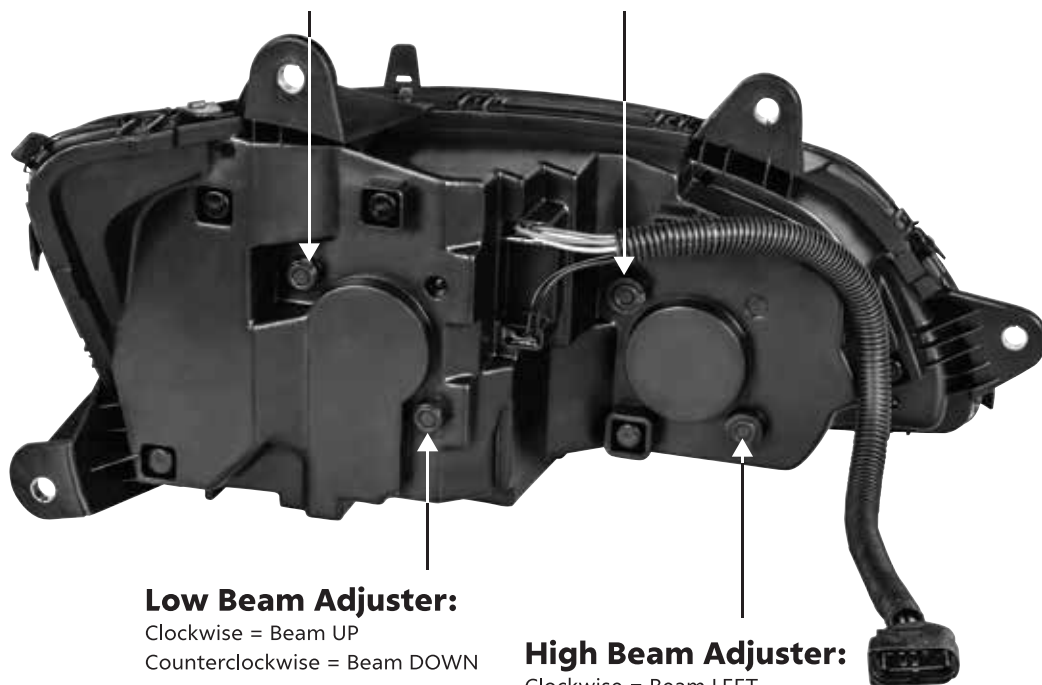
Low Beam Adjuster:

Clockwise = Beam RIGHT
Counterclockwise = Beam LEFT

High Beam Adjuster:

Clockwise = Beam DOWN
Counterclockwise = Beam UP

Clockwise = Beam UP
Counterclockwise = Beam DOWN

Clockwise = Beam LEFT
Counterclockwise = Beam RIGHT
