HIGH POWER LED PROJECTION HEADLIGHT ASSEMBLY

Item #35897, 35898, 35899, 35900

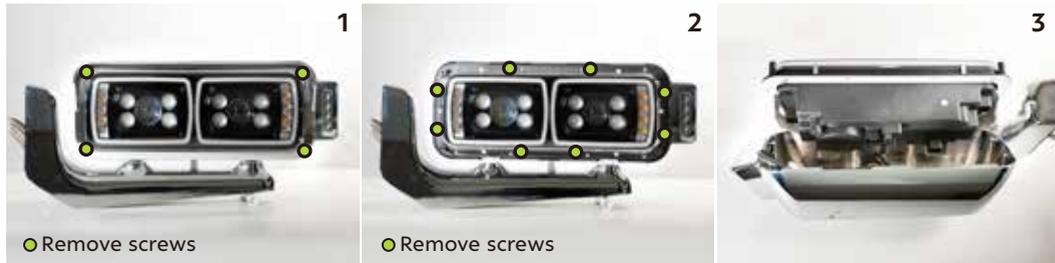
1. Remove headlight bezel by removing the 4 screws.
2. Remove headlight back housing by removing the 8 screws.
3. Carefully move the rear housing back enough to allow access to the headlight adjusters. Remove the 4 plastic caps on the back of the LED headlamp with the included nut driver tool.
4. Once headlight beam adjustment is complete, re-assembly is reverse of steps 1, 2, 3.

1. To adjust the beam:
 - Upper adjuster: clockwise = beam RIGHT
counter clockwise = beam LEFT
 - Lower adjuster: clockwise = beam UP
counter clockwise = beam DOWN
2. Replace the plastic caps on the adjusters when done. Reinstall rear housing (8 screws). Make sure the screws are tight. Replace headlight bezel (4 screws)
